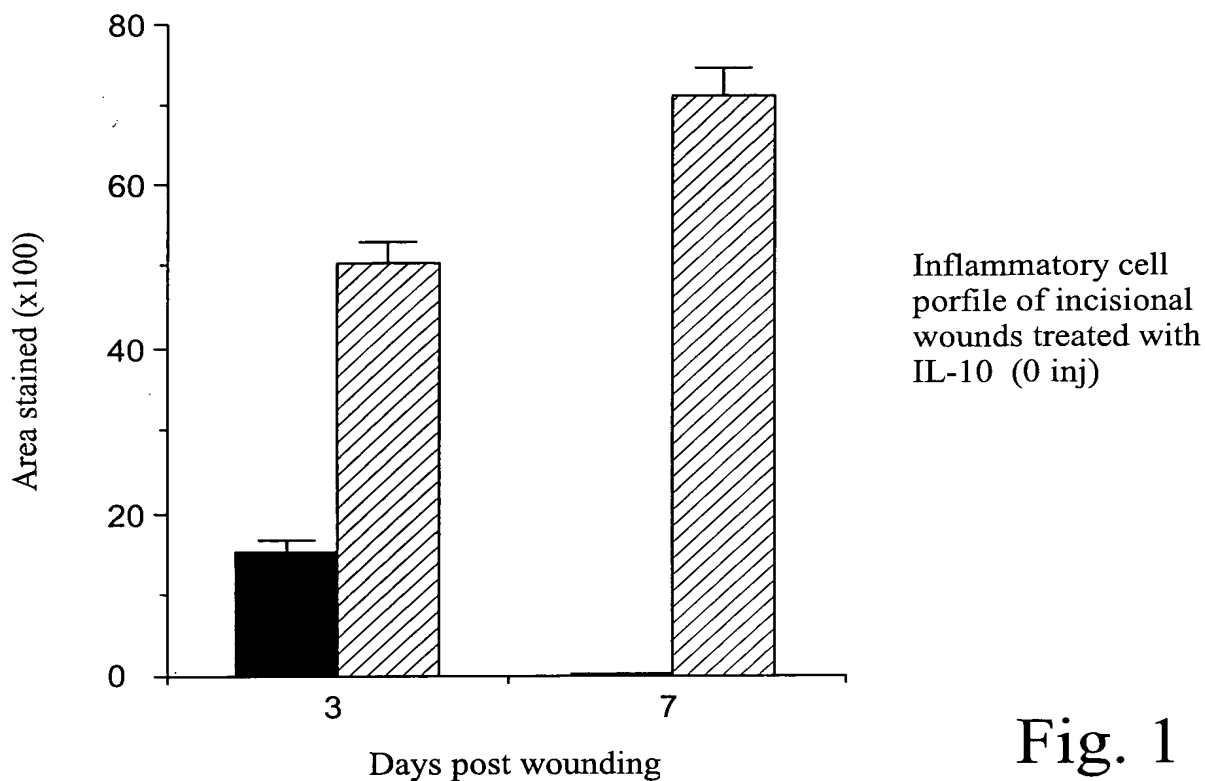
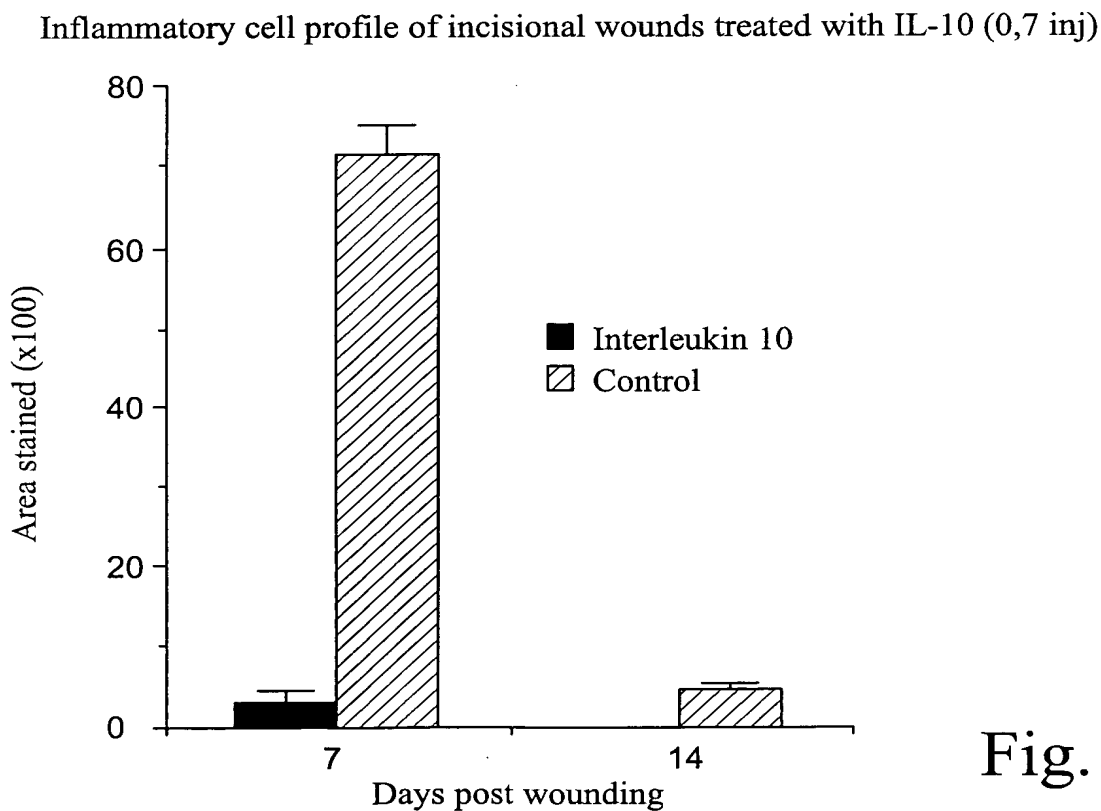
Figure 1 and 2: Inflammatory cell profile (ED1) assessed using image analysis.

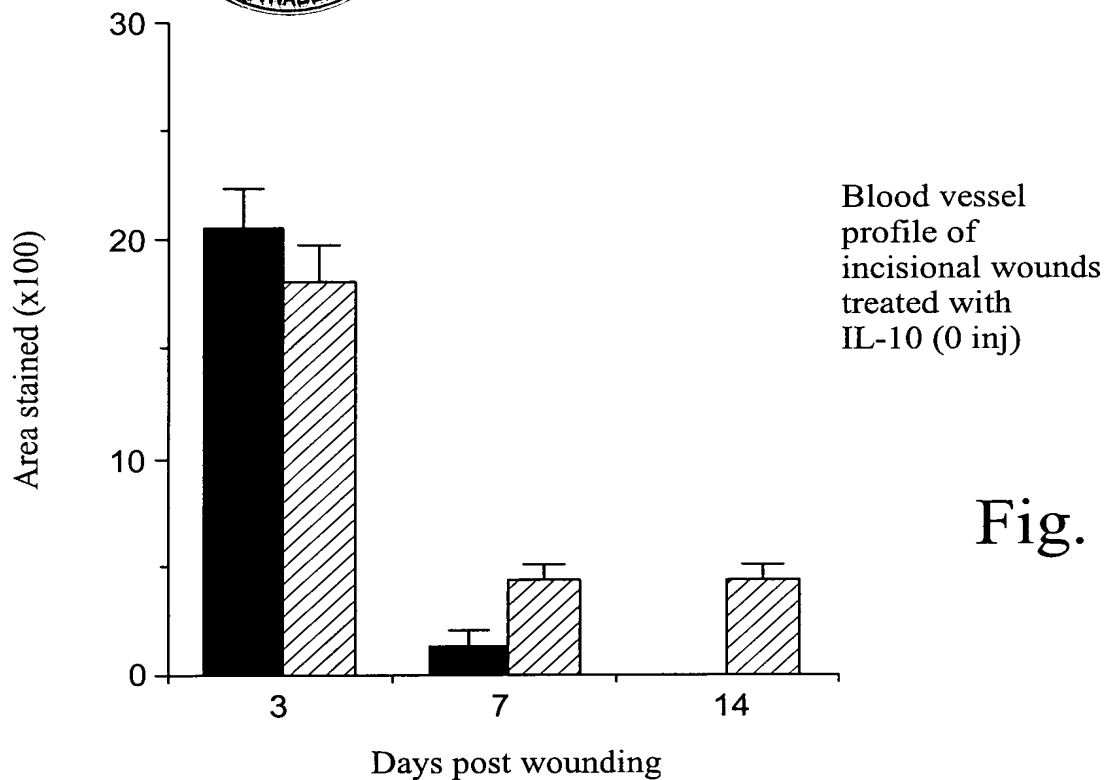
Fig. 3

Blood vessel profile of incisional wounds treated with IL-10 (0,7 inj)

Figure 3 and 4: Blood vessel profile (von Willebrand factor) assessed using image analysis.
